Case 349 : Narrative

Case Vehicle (A): 1998 Ford
Type: Contour, 4-door sedan
Driver: 63-year-old female
CDC: 12-FLEE-4

This is a fatal crash. The driver died as a result of head, neck, and chest injuries sustained during this crash.

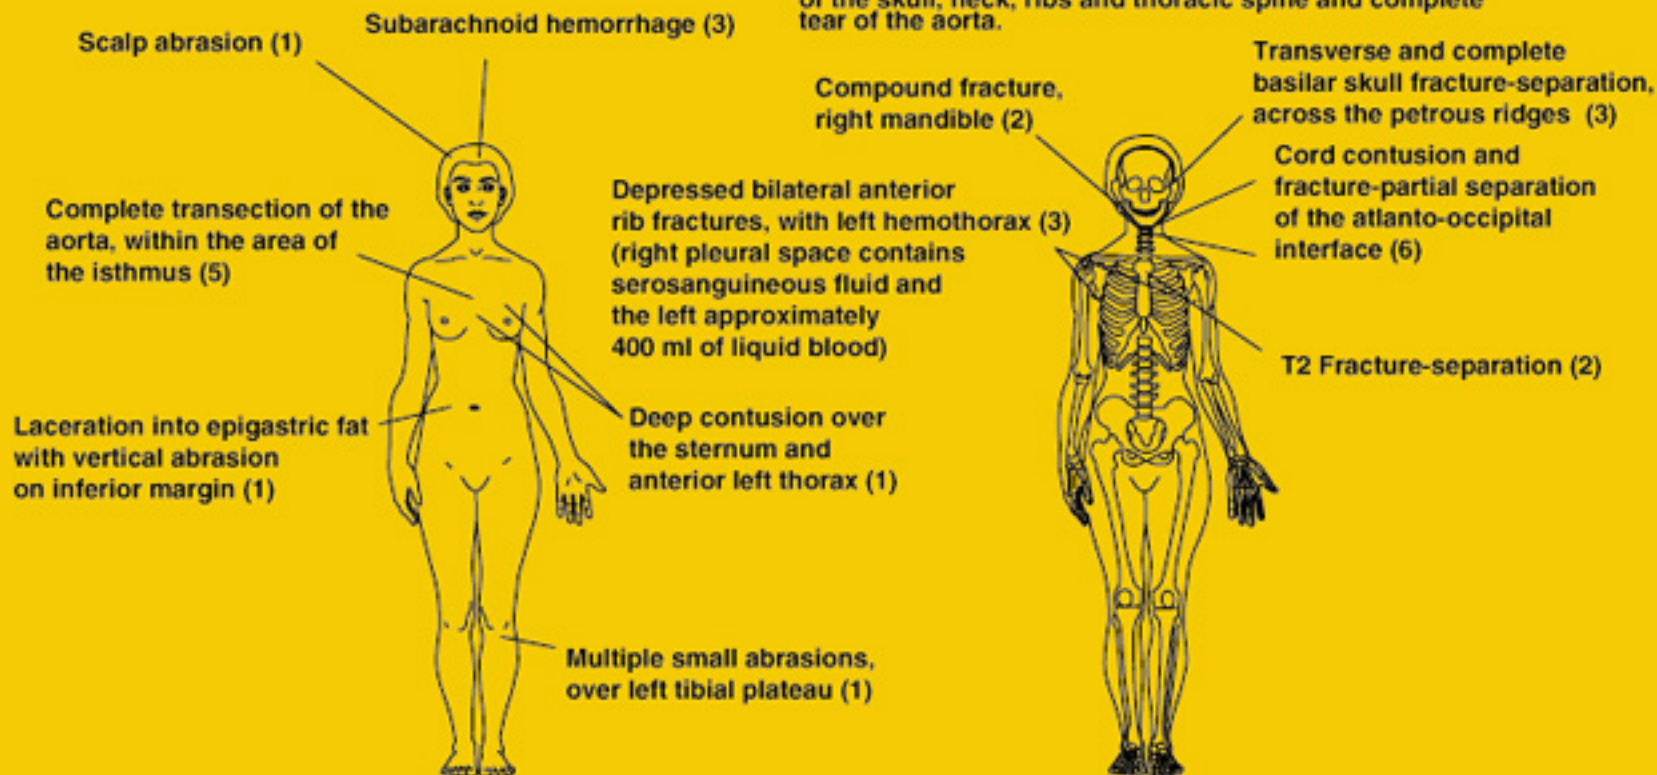
Fatal, autopsy performed, cause of death listed as "multiple injuries" including fractures of the skull, neck, ribs and thoracic spine and complete tear of the aorta.

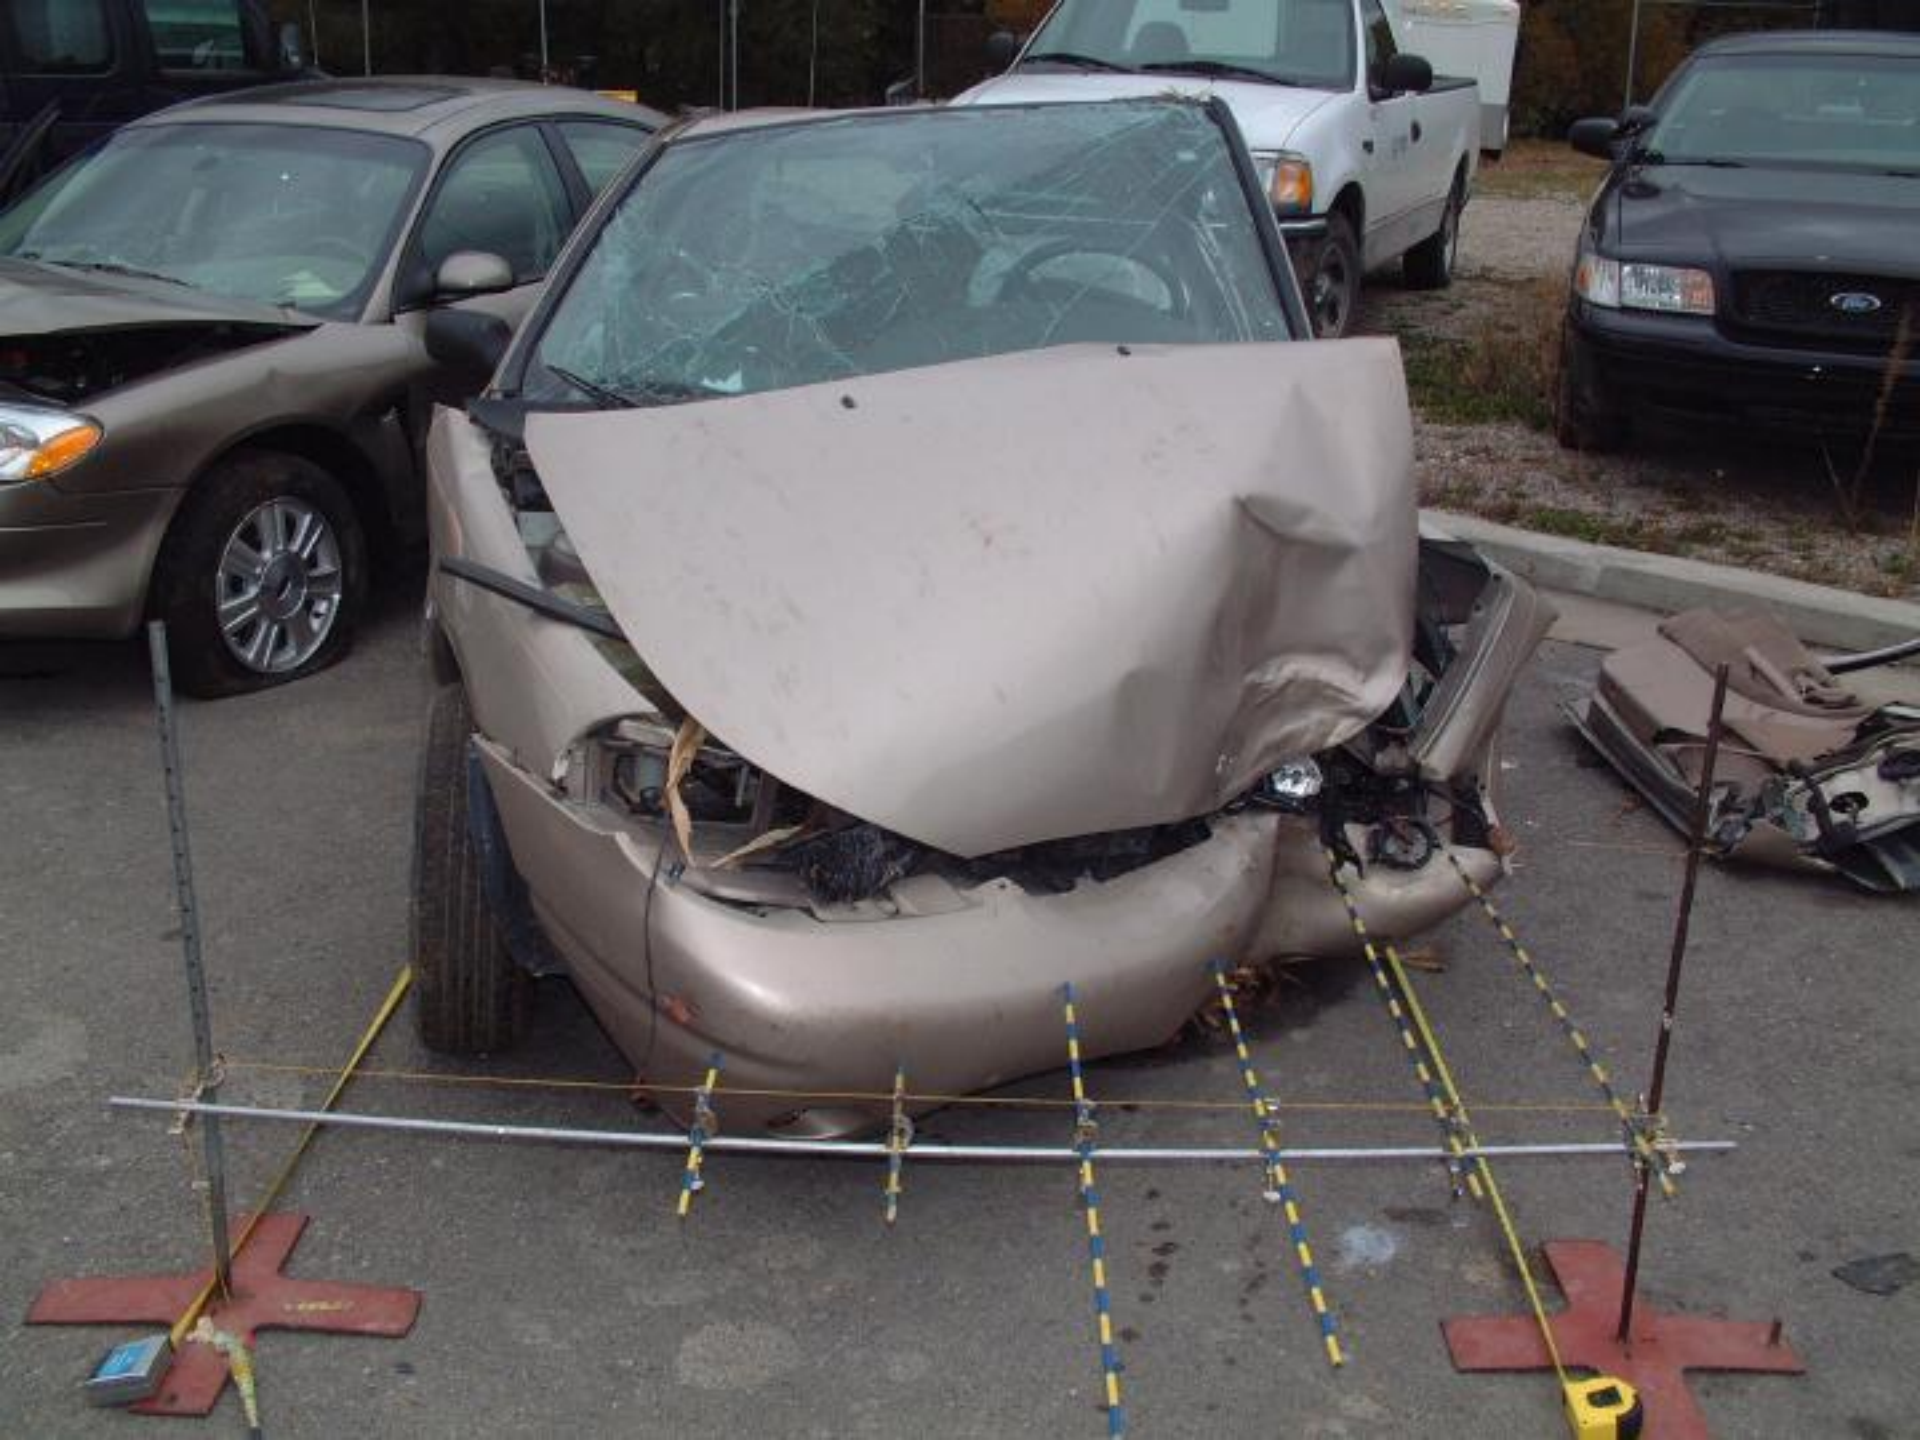
In the front, [19 20](#) the left portions of the bumper, the grille, and the hood were crushed rearward. The whole front end of the case vehicle was shifted to the left, with the left bumper corner shifted 21-cm and the right bumper corner shifted 62-cm. [21](#) The right half of the front clip was pulled forward, resulting in a 10-cm separation of the front of the vehicle from the firewall. [22](#) The front edge of the hood was folded down and buckled rearward. The hood latch was damaged and jammed closed, [23 24](#) both hood hinges were damaged, and the rear edge of the hood was elevated [25](#) and it contacted and cracked the lower-left portion of the

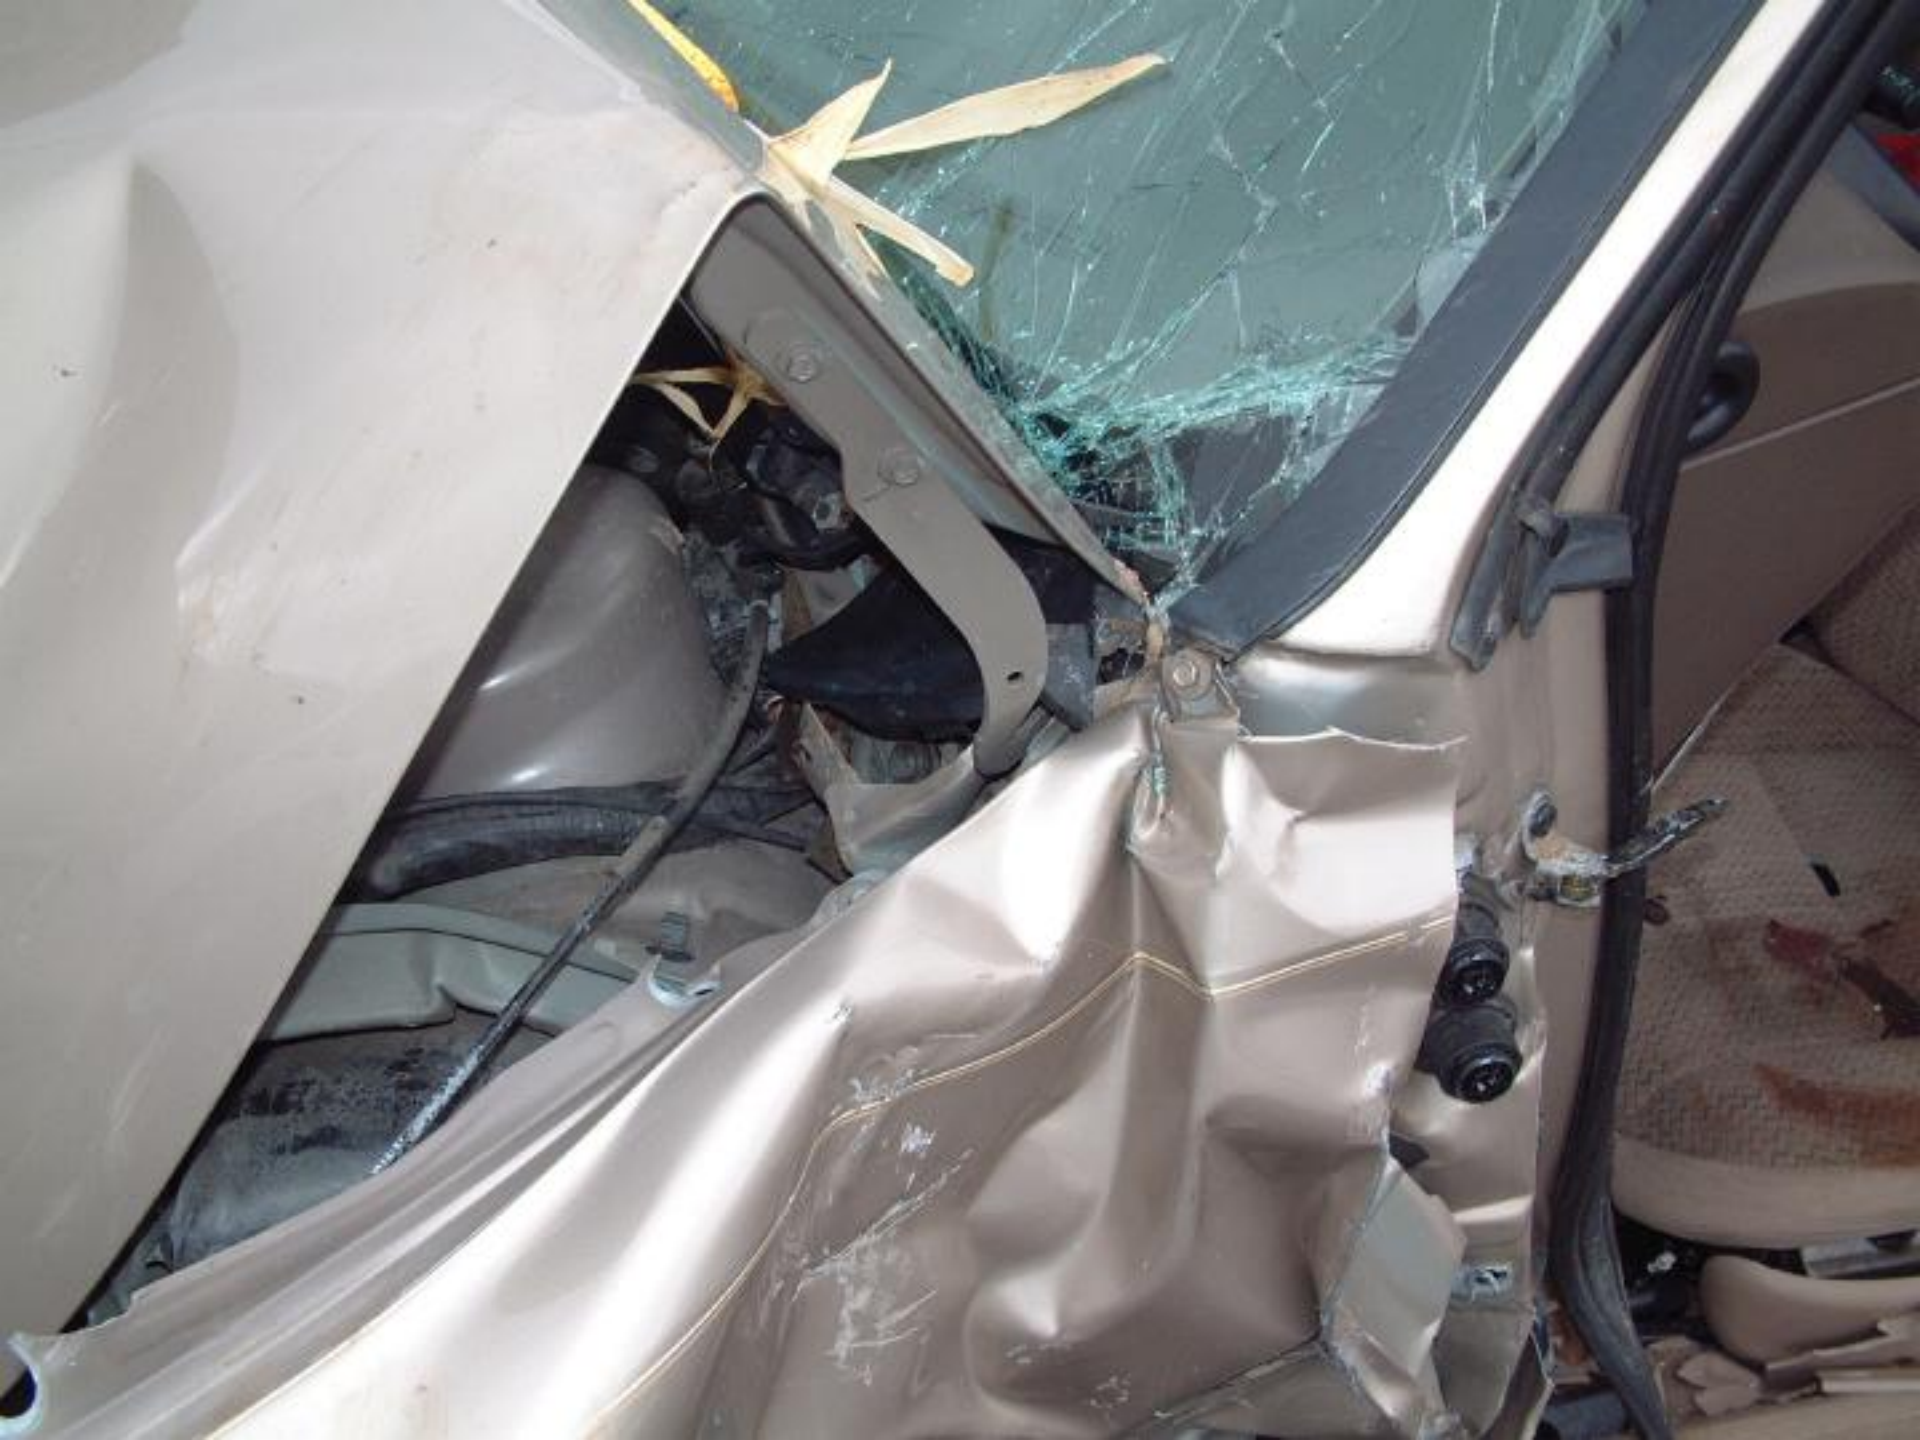
[26](#) On the left side, the fender, the front wheel, and the upper and lower sections of the A- and B-pillars were crushed rearward. The forward portion of the fender was buckled down and [27](#) rotation of the left-front wheel was restricted. [26](#) [28](#) [29](#) Rearward displacement of the left-front wheel and the lower section of the A-pillar caused both left-side doors to be jammed closed, broke out the driver-door window, buckled up the forward portion of the left side of the roof and the left roof siderail, folded down the left-center portion of the roof, and reduced the left wheelbase by 51 cm. The left-rear door glazing was, however, intact. [30](#) [31](#) [32](#) In order to extricate the driver, the hinges on the lower section of the left A-pillar were cut, and the door latch was pried open to remove the driver door. [33](#) There was no damage to the rear of the vehicle.

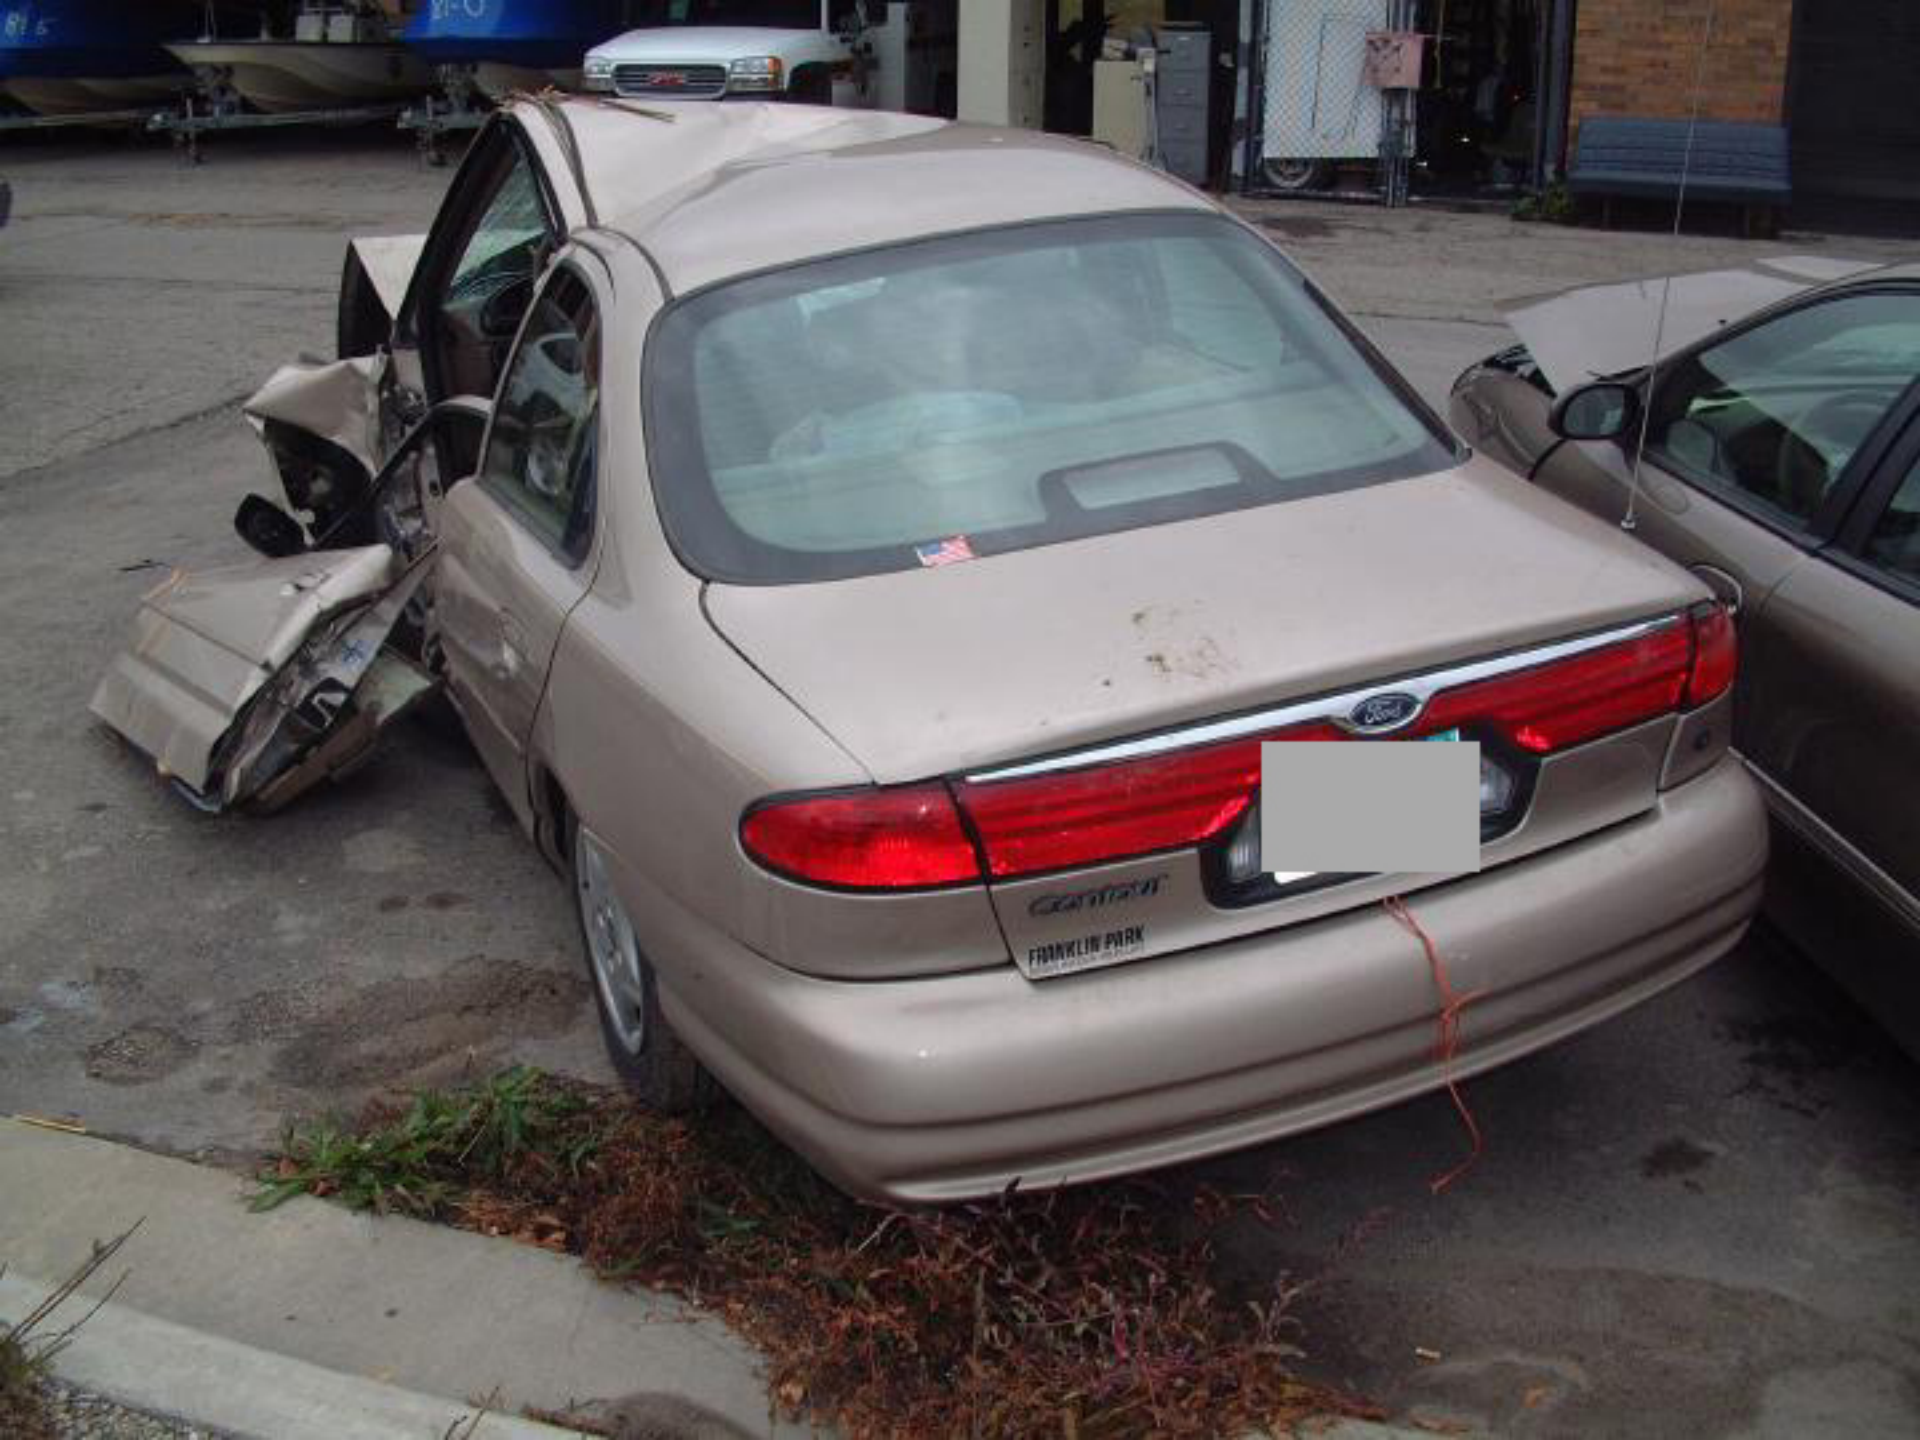
[34](#) On the right side, the fender was deformed, displaced to the left, and pulled forward, [35](#) causing the front of the vehicle to separate from the lower section of the right A-pillar. [36](#) There was no damage to the right-side glazing, both right-side doors were closed and operational, but the right wheelbase was increased 7 cm.
